# Inspection Report

## Allround Pest Management

**11 Sovereign Close, Floraville, NSW, 2280**

## TIMBER PEST INSPECTION

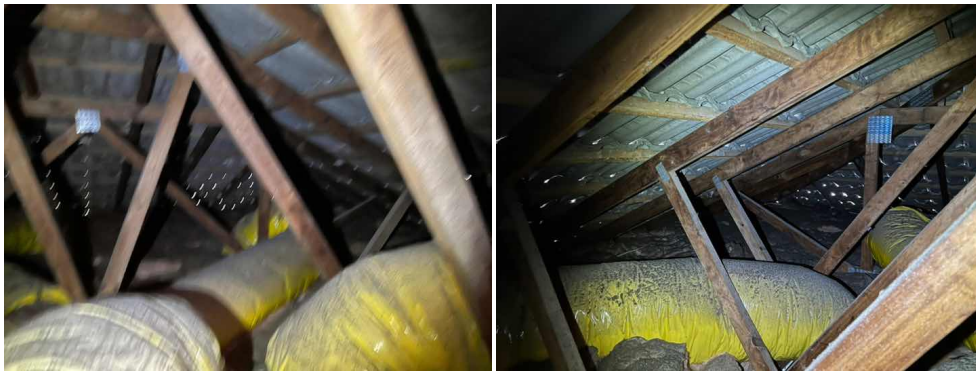
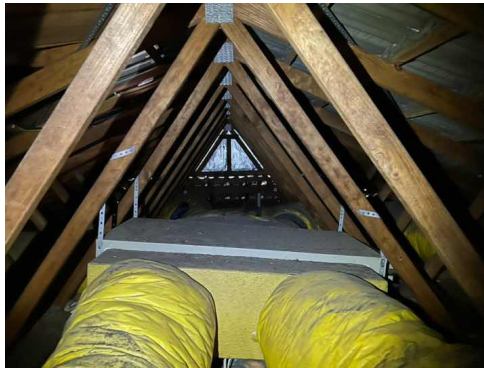
Insulation batts

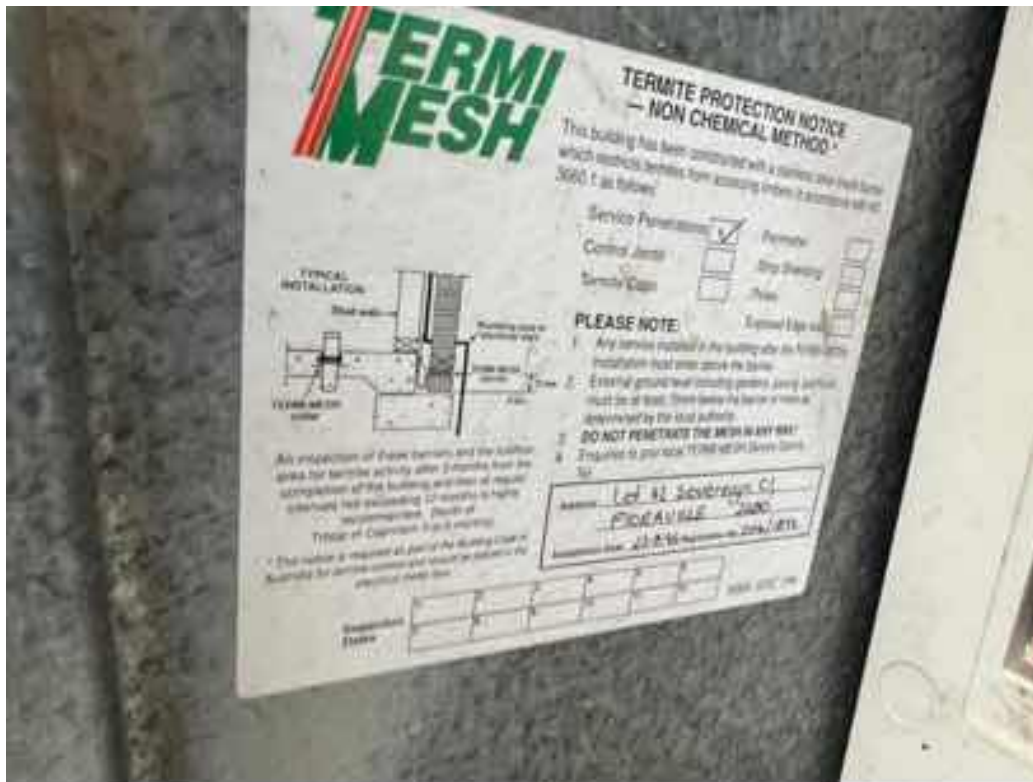
#### **Any Evidence of previous Treatments Found**

Yes, termite management at time of construction

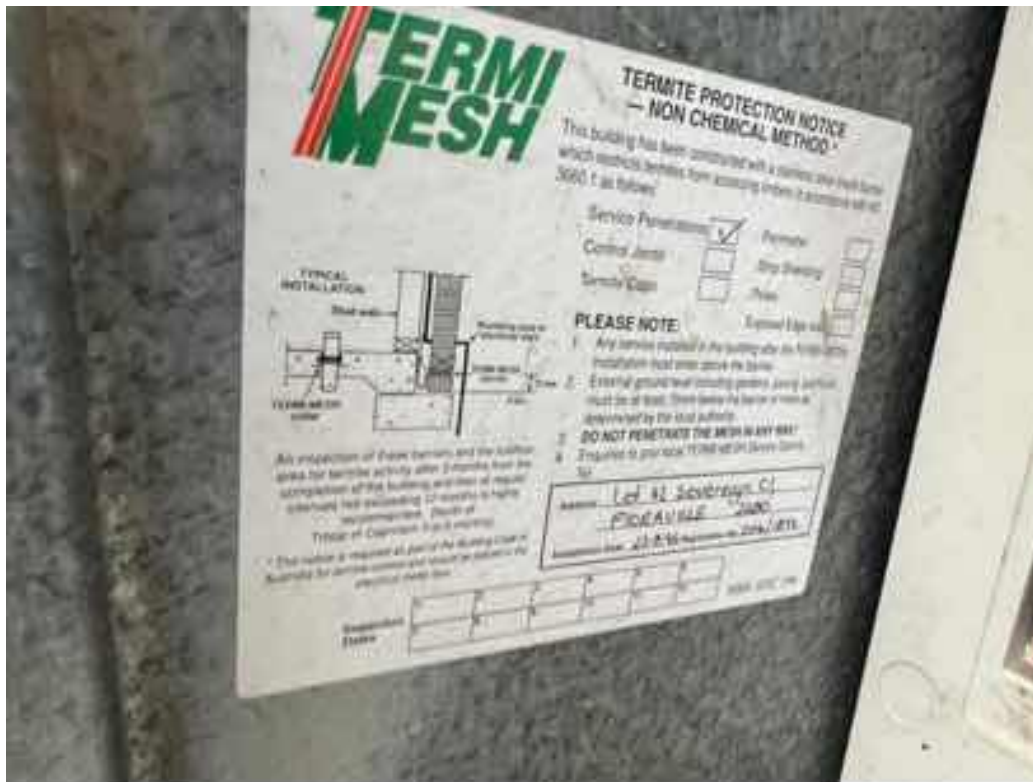
### Was a Treatment Notice Found

Yes, a durable notice was found during the inspection.

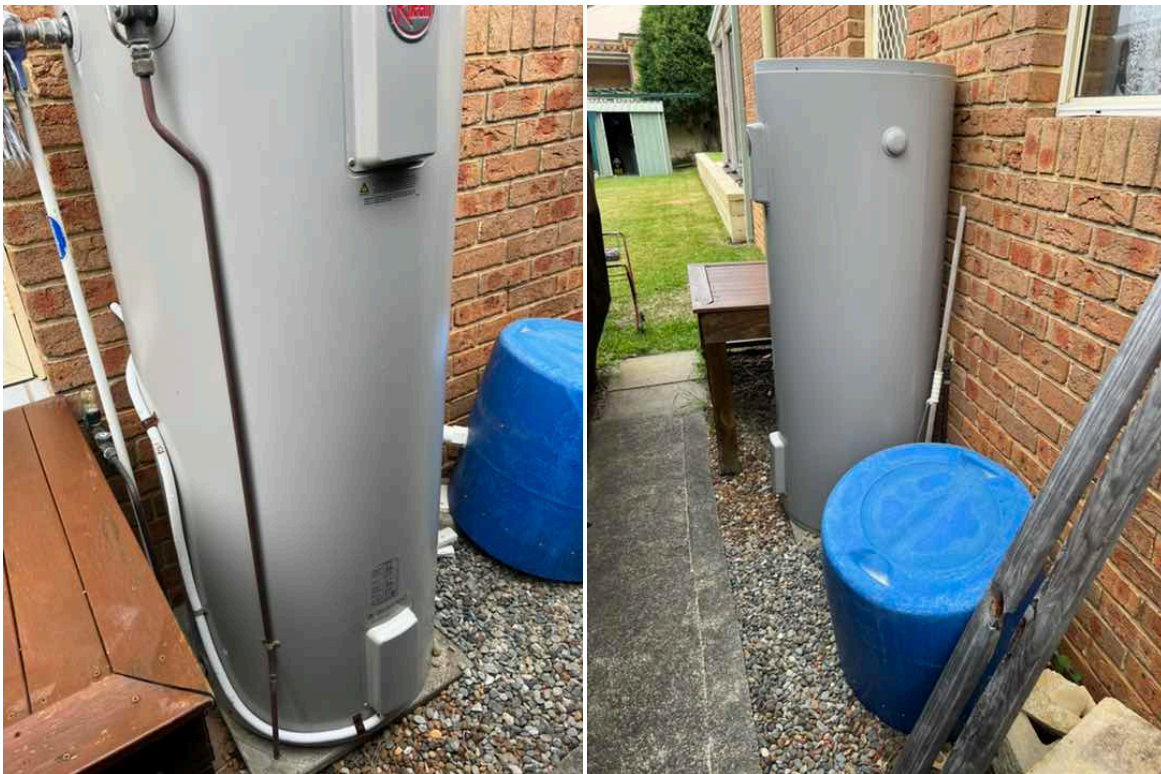
#### **Was the overflow sufficiently drained**

No - Divert hot water overflow away from the building perimeter

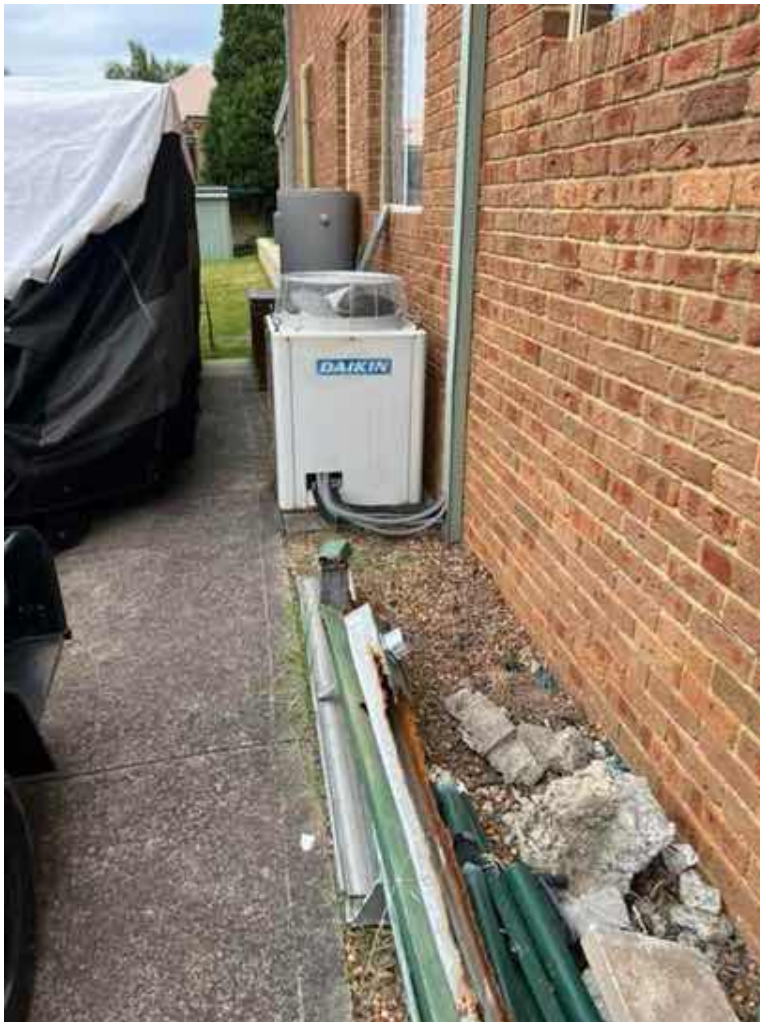
#### **Was the Air Conditioner Sufficiently Drained**

Yes

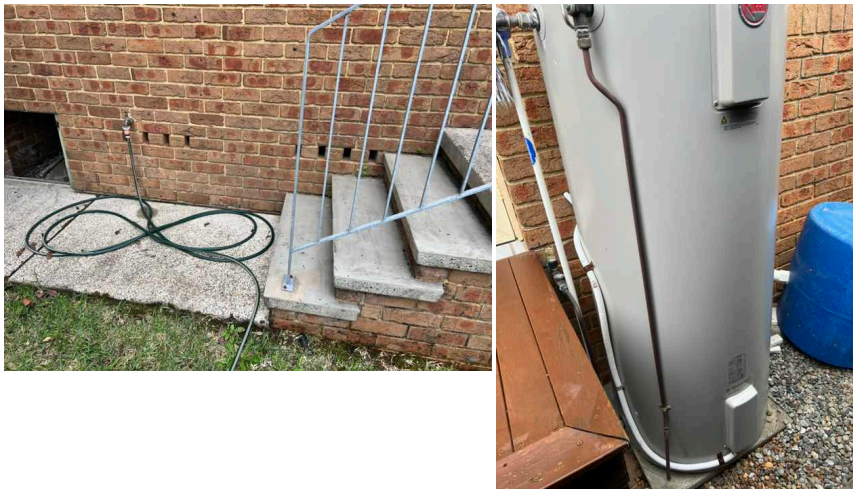
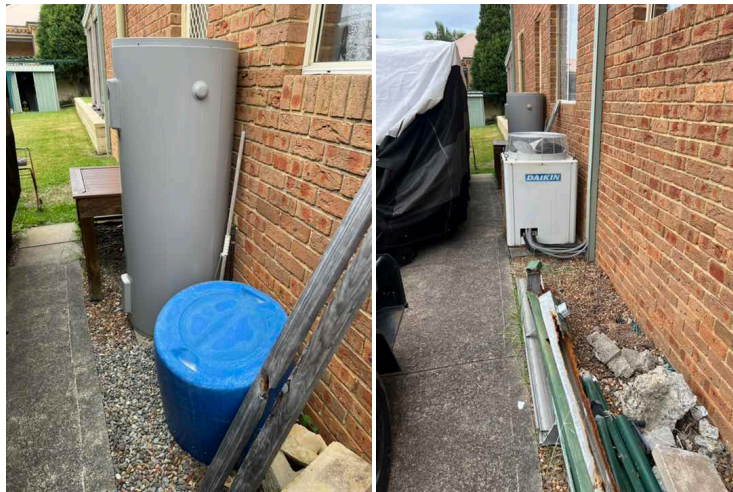
Hot water unit overflow not connected to drain. This provides conducive conditions for termite infestation.

The slab edge is not exposed. The slab edge must be exposed so that a thorough inspection can be conducted for any termite infestation/access points.
