LAKE MACQUARIE
**BUILDING
INSPECTIONS**

Inspection Report No: 4508

Client Name: [REDACTED]
Property Address: 11 Sovereign Close, Floraville.

The Standard Property Report (Except ACT) Complies with Australian Standard
AS 4349.1- 2007 Inspection of Buildings Part 1: Pre-Purchase Inspections –
Residential Buildings

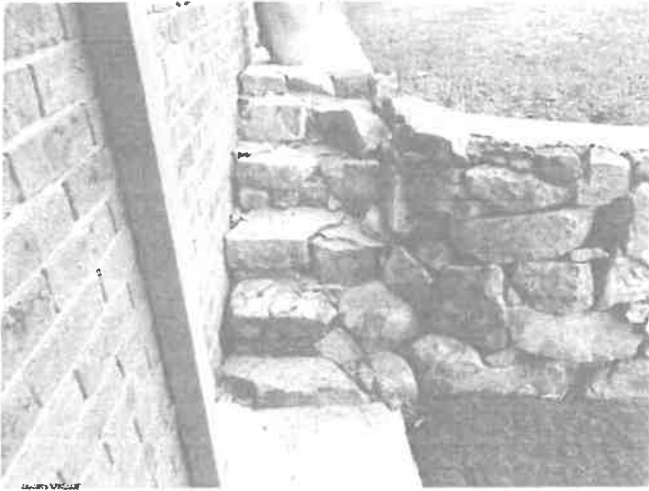
- Minor cracking noted to the driveway slabs/perimeter pavement (typical).
- Inconsistent and uneven risers and goings noted to the landscaping steps. Beware of trip hazards. (Photo page 6)

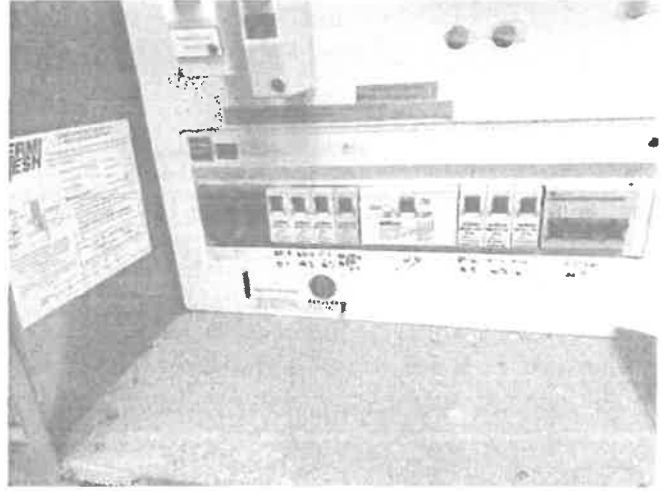
- Meter box; RCD safety switches fitted; however, protected circuits are not clearly identified. Consult a licensed electrician for further advice. (Photo page 6)
- The bushrock retaining wall appears in stable and serviceable condition.

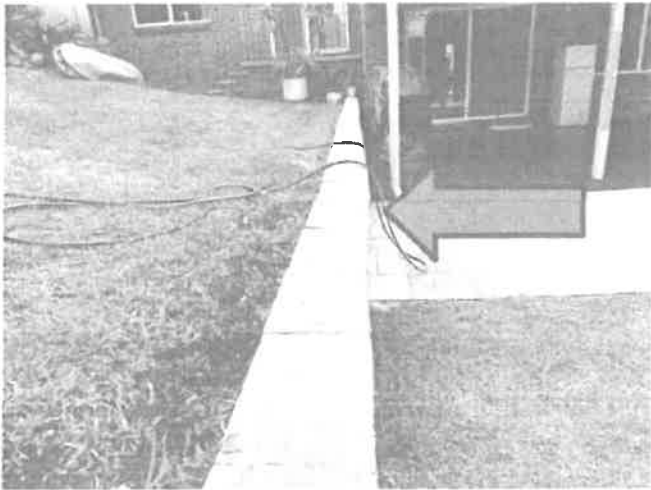
- Minor lateral rotation noted to the flexible masonry retaining wall; however, appears in generally stable and serviceable condition at time of the inspection. (Photo page 6)

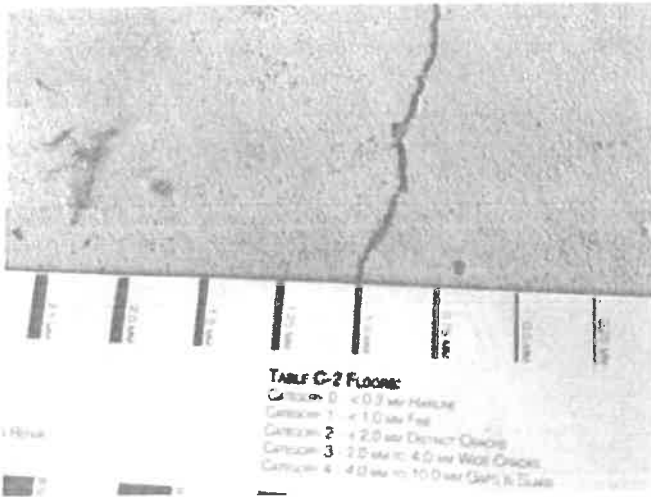
- Fine cracking to 1mm noted to the floor slab (typical). (Photo page 9)
- Automatic door opener fitted (not tested).

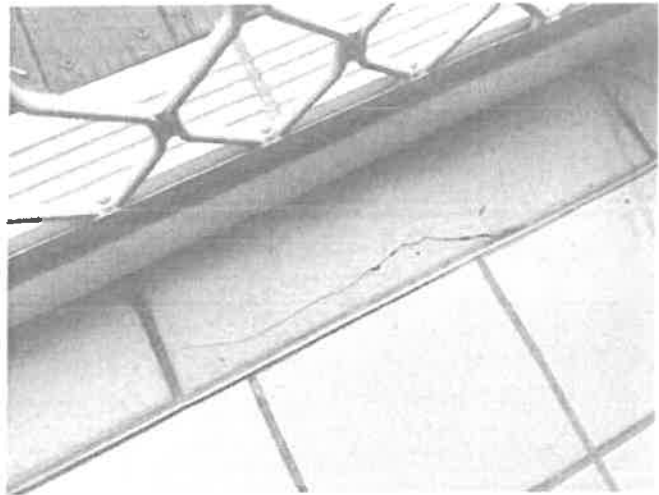
- Minor cracking noted in the external threshold tile (typical). (Photo page 9)

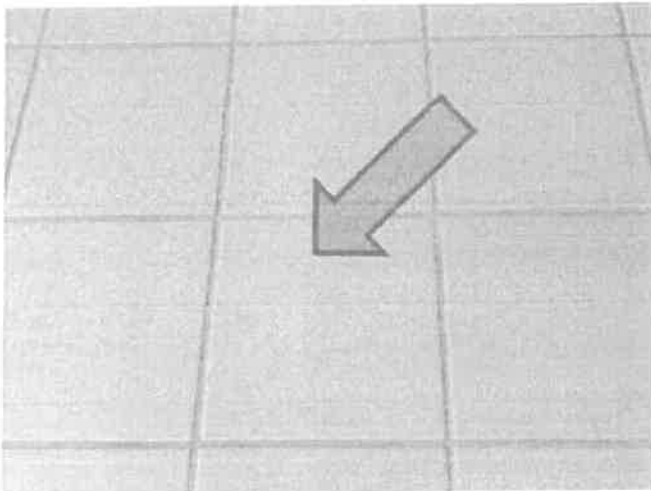
The ensuite shower has undergone recent contractor sealant improvements, we recommend making available any relevant warranties for the works to a prospective buyer.

- Recent sealing improvements noted to the shower recess as per the summary. (Photo page 9)

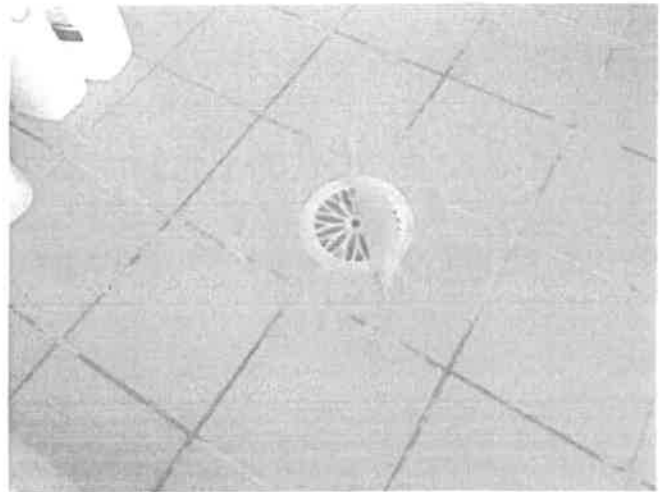
- Minor cracking noted to the floor tiles. (Photo page 9)
- Consider grouting improvements to the shower recess floor tiles. (Photo page 9)
- Shower recess was flood tested.

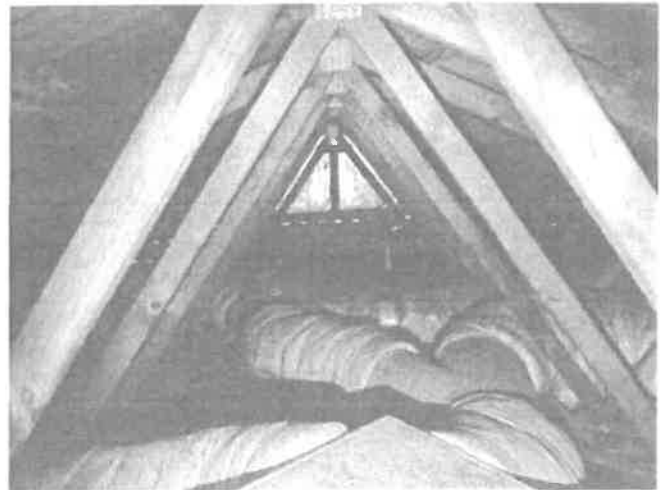
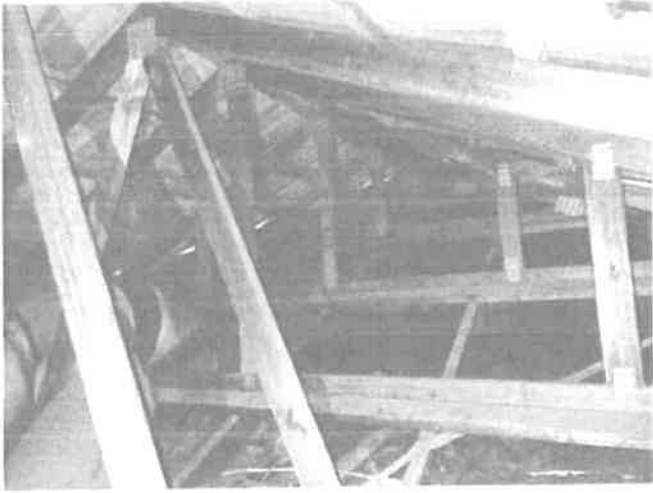
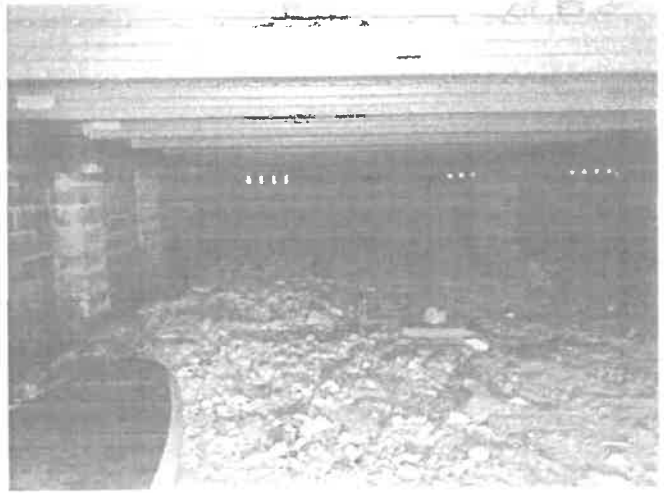
- The roof frame appears generally true and adequately braced. (Photos page 9 & 10)
- Insulation batts fitted over the ceilings.
- No sarking foil fitted under the roof tiles.
- Roof ventilation noted.

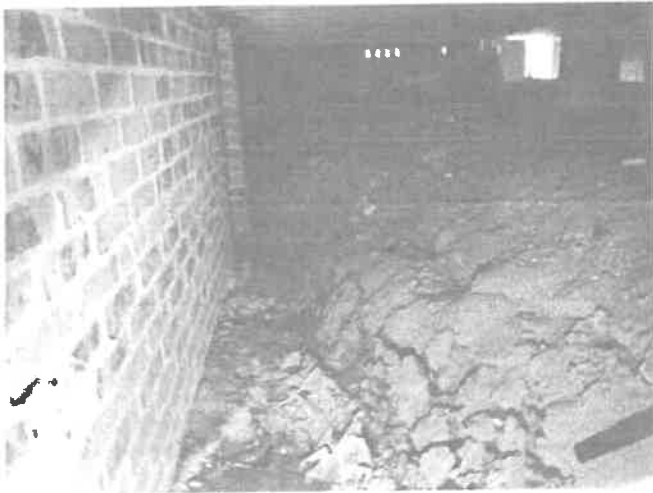
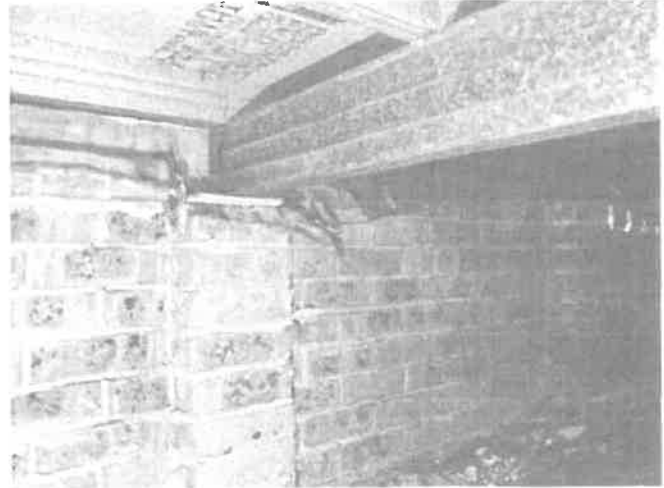
- The steel bearers and joists appear in sound condition. (Photo page 10)
- No drainage provisions noted.
- Generally dry soils noted. (Photo page 10)
- Adequate ventilation.
