LAKE MACQUARIE
**BUILDING
INSPECTIONS**

Inspection Report No: 4508

Client Name: [REDACTED]
Property Address: 11 Sovereign Close, Floraville.

The Standard Property Report (Except ACT) Complies with Australian Standard
AS 4349.1- 2007 Inspection of Buildings Part 1: Pre-Purchase Inspections –
Residential Buildings

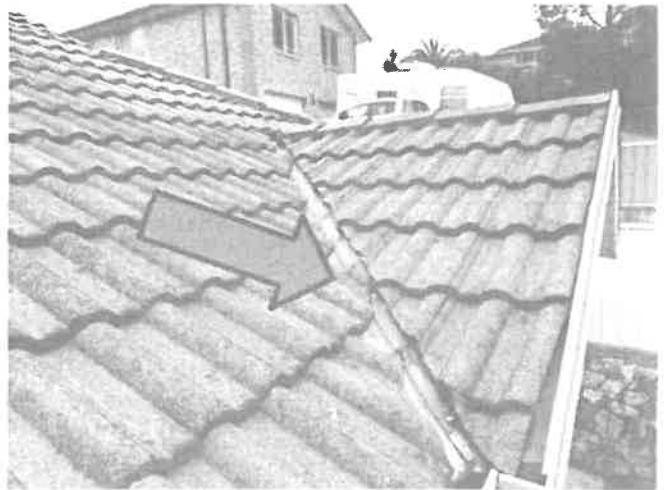
- The tiles and capping appear in generally good serviceable condition.
- Sealant improvements required to apron flashings as per summary. (Photo page 6)
- Resecure dislodged valley tiles. (Photo page 6)
- Gutter and downpipes appear in generally good serviceable condition.
- No leaf guard fitted to gutters and valleys.
- Solar voltaic panels noted on the western roof planes.

Minor sealant improvements are strongly recommended to fatigue cracking in the lead apron flashings to prevent water ingress issues.
